**Flood Control Project Maintenance  
Levee Inspections**  
**LMA District Cover Sheet**  
**Spring 2019 Levee Inspection Results**

**Reclamation District No. 0999 Netherlands**

**Spring 2019 Levee Inspection Results**

Waterway			Bank	Unit Miles
Unit No. 01 Yolo Bypass			Left	15.41
	Spring (March - May)	Summer (June - August)	(September - November) Fall	Winter (December - February)
Unit Maintenance Rating (Fall Only)				
Date of Inspection	3/21/2019 - 3/21/2019			
DWR Inspector	Luz Dial			
Accompanied By

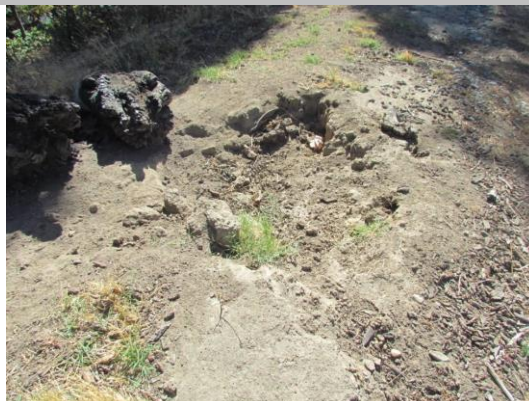
Photo 1 of 3 : SP\_2019\_RD0999\_236\_176\_20190307\_00083.jpg

LM Start	5.12	Rating **	M	Issue No.	176
LM End	5.12	Issue Type +	Ma	Location *	WS
Category	Earthen Levee			GPS Latitude/Longitude	
				Start	End
Item	Slope Stability			38.380420 °	38.380420 °
				-121.541102 °	-121.541102 °
DWR ID	DWR_RD0999_05_f_2015_176				
Comment Code					
S1 : Repair slope instability.					
Inspector Comment					
Large hole on waterside shoulder remains, but tree was removed.

Looking at hole from fallen tree on waterward shoulder. (Fall 2016)

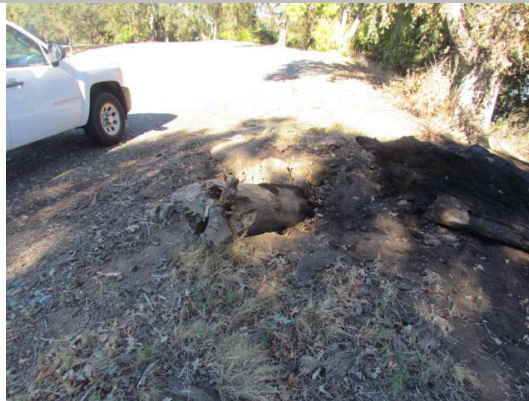
Photo 2 of 3 : SP\_2019\_RD0999\_236\_176\_20190307\_00084.jpg

LM Start	5.12	Rating **	M	Issue No.	176 (cont)	
LM End	5.12	Issue Type +	Ma	Location *	WS	
Category	Earthen Levee			GPS Latitude/Longitude		
				Start		End
Item	Slope Stability			38.380420 °		38.380420 °
				-121.541102 °		-121.541102 °
DWR ID	DWR_RD0999_05_f_2015_176					
Comment Code						
S1 : Repair slope instability.						
Inspector Comment						
Large hole on waterside shoulder remains, but tree was removed.

Looking at hole on waterward shoulder caused by fallen tree.

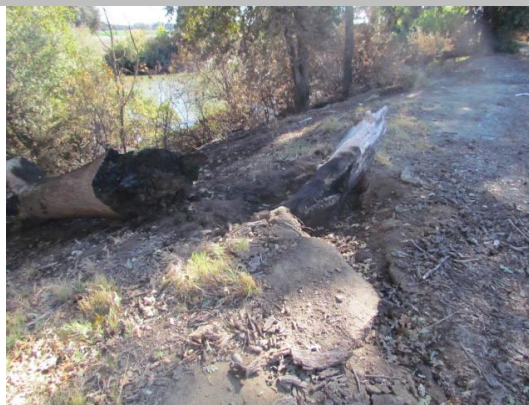
Photo 3 of 3 : SP\_2019\_RD0999\_236\_176\_20190307\_00085.jpg

Looking at fallen tree and hole on waterward slope and shoulder.

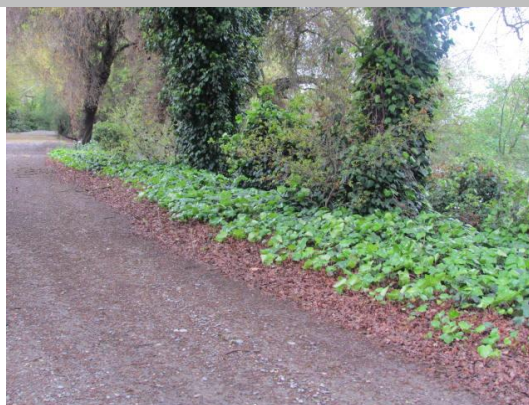
Photo 2 of 2 : SP\_2019\_RD0999\_236\_43\_20190307\_00022.jpg

Looking northeast at dense groundcover and vegetation on waterside slope.

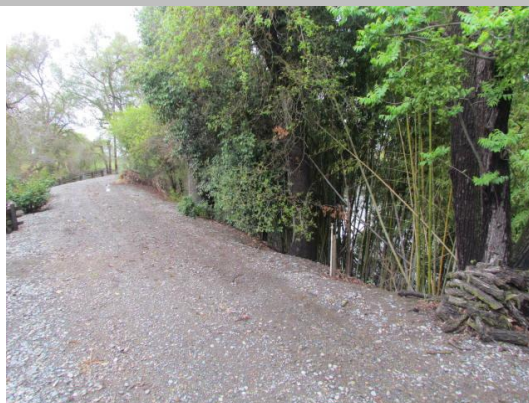
Photo 1 of 1 : SP\_2019\_RD0999\_236\_71\_20190307\_00030.jpg

LM Start	5.50	Rating **	U	Issue No.	71
LM End	5.55	Issue Type +	Ma	Location *	WS
Category	Earthen Levee			GPS Latitude/Longitude	
				Start	End
Item	Vegetation			38.382790 °	38.383548 °
				-121.546754 °	-121.546728 °
DWR ID	DWR_RD0999_05_s_2012_71				
Comment Code					
V2 : Remove the wild growth other than native grasses from the levee slopes.					
Inspector Comment

Looking northeast at dense vegetation on waterside slope.

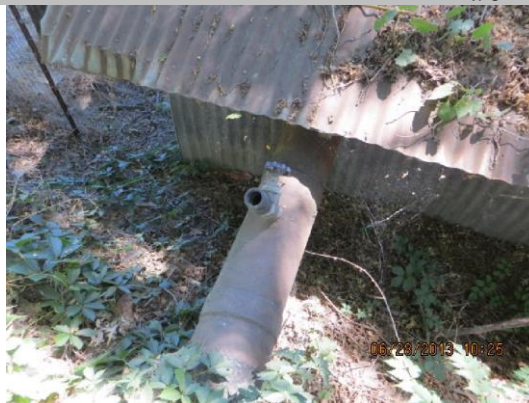
Photo 3 of 3 : UCIP\_SP\_2019\_15446\_25364.jpg

Comment Code						
Inspector Comment						
FS_ID:15446 DS_ID:22857 EP_NO: N/A Repair Type: Non-Urgent Crossing Status: Found UCIP Comments: Pipe appears abandoned and should be done so appropriately. FIELD_STRUCT_DESC: 10-inch steel irrigation pipe through the levee, 4 feet below the crown. Pump house and gate valve on the waterside (WS) slope. Vent on the landside (LS) slope, and a 42-inch concrete standpipe on the LS toe. Service pole on the LS slope with a 1.5-inch galvanized iron electrical conduit at the same location. [Additional Reference(s): DWR Levee Log, 1992. USACE Sacramento O&M Manual 113 (Revised), October 1966, (HLM 5.66) (8-inch pipe listed)]. FS Date: 6/28/2013

Vent on pipe at WS shoulder.

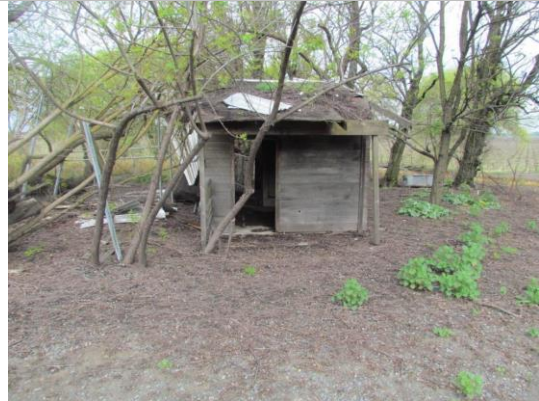
Photo 2 of 2 : SP\_2019\_RD0999\_236\_37\_20190307\_00020.jpg

LM Start	5.57	Rating **	U	Issue No.	37 (cont)	
LM End	5.57	Issue Type +	En	Location *	LS	
Category	Earthen Levee			GPS Latitude/Longitude		
				Start	End	
Item	Encroachments			38.383780 °	38.383780 °	
				-121.546590 °	-121.546590 °	
DWR ID	DWR_RD0999_05_s_2017_37					
Comment Code						
BU : Building						
Inspector Comment						
Dilapidated horse pen on landside slope and fallen tree need to be removed from easement.

Looking west at dilapidated horse pen and fallen tree on landward slope.

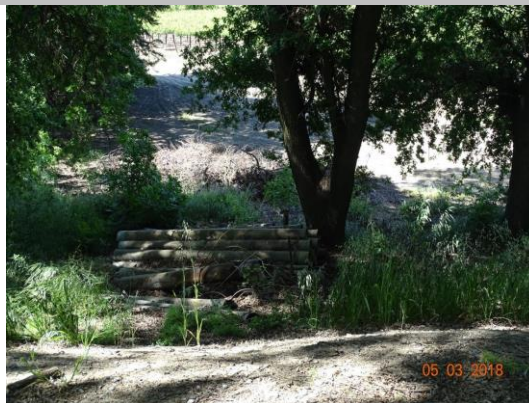
Photo 1 of 1 : SP\_2019\_RD0999\_236\_77\_20190307\_00032.jpg

LM Start	6.08	Rating **	M	Issue No.	77
LM End	6.08	Issue Type +	En	Location *	LS
Category	Earthen Levee			GPS Latitude/Longitude	
				Start	End
Item	Encroachments			38.387522 °	38.387522 °
				-121.542135 °	-121.542135 °
DWR ID	DWR_RD0999_05_s_2018_77				
Comment Code					
PI : Pipe					
Inspector Comment

Poles stored at landside toe looking northwest. Spring 2018

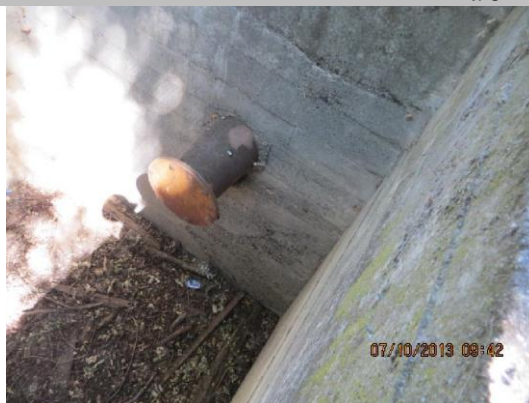
Photo 1 of 2 : UCIP\_SP\_2019\_15604\_25875.jpg

LM Start	6.47	Rating **	M	Issue No.	244
LM End	6.47	Issue Type +	En	Location *	
Category	Supplemental			GPS Latitude/Longitude	
				Start	End
Item	DWR UCIP Field Study			38.391723 °	38.391723 °
				-121.539442 °	-121.539442 °
DWR ID	22860				
Comment Code					
Inspector Comment					
FS_ID:15604 DS_ID:22860 EP_NO: N/A Repair Type: Non-Urgent Crossing Status: Found UCIP Comments: Pipe abandoned and should be done so properly. FIELD_STRUCT_DESC: *ABANDONED* 14-inch steel drainage pipe through the levee, 7.2 feet below the crown. Open 9-foot by 14-foot concrete pump pit on the waterside (WS) slope. Pipe has steel plate bolted over the WS end. [Additional Reference(s): DWR Levee Log, 1992. USACE Sacramento O&M Manual 113 (Revised), October 1966, (HLM 6.61)]. FS Date: 7/10/2013

Pipe with steel plate bolted over opening at concrete pump pit on WS toe.

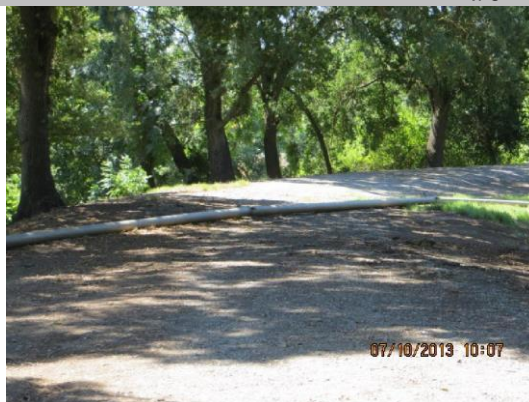
Photo 1 of 2 : UCIP\_SP\_2019\_16342\_27544.jpg

LM Start	6.56	Rating **	M	Issue No.	245
LM End	6.56	Issue Type +	En	Location *	
Category	Supplemental			GPS Latitude/Longitude	
				Start	End
Item	DWR UCIP Field Study			38.392788 °	38.392788 °
				-121.539047 °	-121.539047 °
DWR ID	23988				
Comment Code					
Inspector Comment					
FS_ID:16342 DS_ID:23988 EP_NO: N/A Repair Type: Non-Urgent Crossing Status: Found UCIP Comments: Need to determine Permit No. for this crossing. FIELD_STRUCT_DESC: 8-inch aluminum irrigation pipe over the top of the levee. Pipe blocks crown when in use. Portable pump on the waterside (WS) toe. FS Date: 7/10/2013

Pipe at crossing over crown.

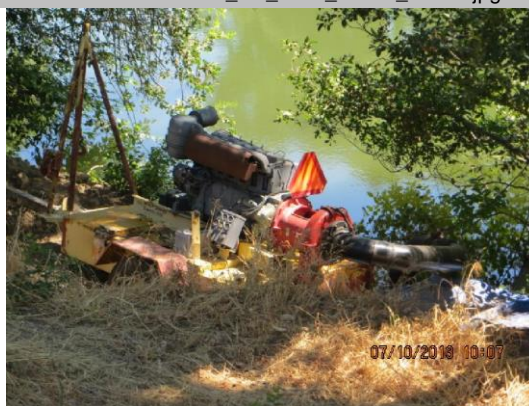
Photo 2 of 2 : UCIP\_SP\_2019\_16342\_27543.jpg

LM Start	6.56	Rating **	M	Issue No.	245 (cont)
LM End	6.56	Issue Type +	En	Location *	
Category	Supplemental			GPS Latitude/Longitude	
				Start	End
Item	DWR UCIP Field Study			38.392788 °	38.392788 °
				-121.539047 °	-121.539047 °
DWR ID	23988				
Comment Code					
Inspector Comment					
FS_ID:16342 DS_ID:23988 EP_NO: N/A Repair Type: Non-Urgent Crossing Status: Found UCIP Comments: Need to determine Permit No. for this crossing. FIELD_STRUCT_DESC: 8-inch aluminum irrigation pipe over the top of the levee. Pipe blocks crown when in use. Portable pump on the waterside (WS) toe. FS Date: 7/10/2013

Portable pump on WS toe.

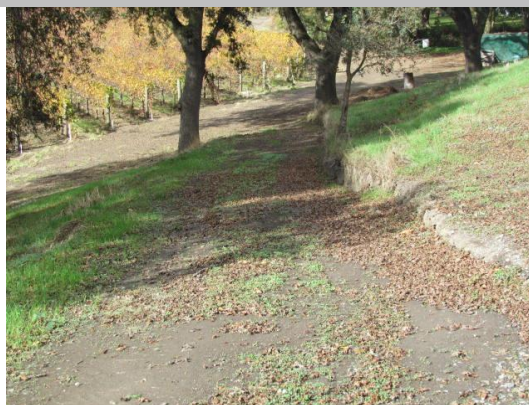
Photo 1 of 1 : SP\_2019\_RD0999\_236\_132\_20190307\_00055.jpg

LM Start	6.61	Rating **	M	Issue No.	132
LM End	6.61	Issue Type +	En	Location *	LS
Category	Earthen Levee			GPS Latitude/Longitude	
				Start	End
Item	Encroachments			38.393578 °	38.393578 °
				-121.539295 °	-121.539295 °
DWR ID	DWR_RD0999_05_f_2012_132				
Comment Code					
RA : Ramp					
Inspector Comment					
Landowner installed ramp on landside slope without permit.

Looking east at unauthorized ramp on landside slope.

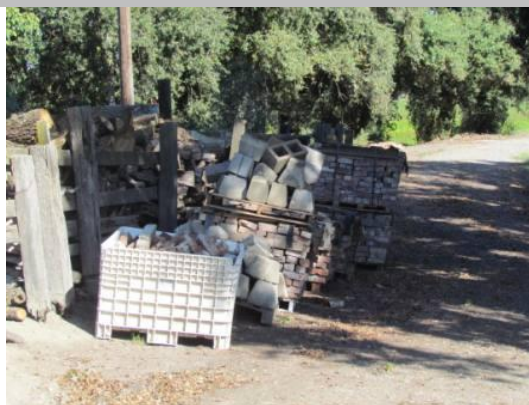
Photo 4 of 4 : SP\_2019\_RD0999\_236\_96\_20190307\_00043.jpg

Looking north at firewood and other material on landside shoulder and crown.

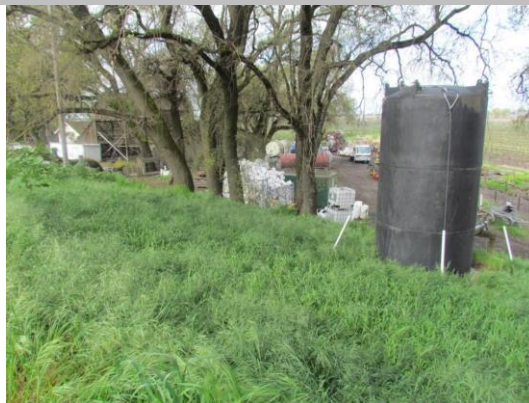
Photo 1 of 2 : SP\_2019\_RD0999\_236\_226\_20190307\_00103.jpg

LM Start	6.76	Rating **	U	Issue No.	226
LM End	6.76	Issue Type +	En	Location *	LS
Category	Earthen Levee			GPS Latitude/Longitude	
				Start	End
Item	Encroachments			38.395668 °	38.395668 °
				-121.539149 °	-121.539149 °
DWR ID	DWR_RD0999_05_s_2017_226				
Comment Code					
TA : Tank					
Inspector Comment					
Instruct landowner to remove large water tank on landside slope and other material from easement.

Looking west at water tank on landward slope.

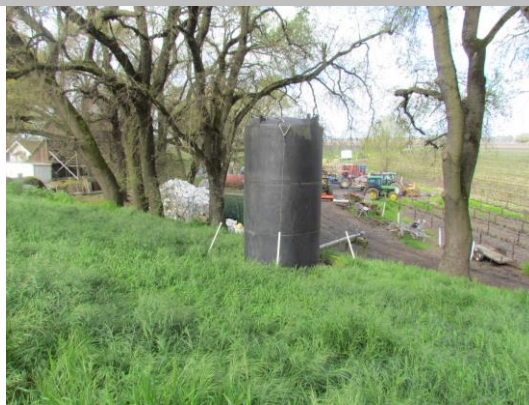
Photo 2 of 2 : SP\_2019\_RD0999\_236\_226\_20190307\_00104.jpg

Looking west at water tank on landward slope and toe.

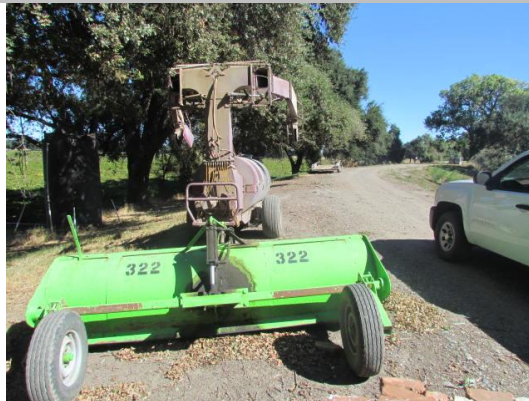
Photo 2 of 3 : SP\_2019\_RD0999\_236\_156\_20190307\_00067.jpg

LM Start	6.76	Rating **	M	Issue No.	156 (cont)	
LM End	6.83	Issue Type +	En	Location *	LS	
Category	Earthen Levee			GPS Latitude/Longitude		
				Start	End	
Item	Encroachments			38.395707 °	38.396307 °	
				-121.539157 °	-121.538177 °	
DWR ID	DWR_RD0999_05_f_2013_156					
Comment Code						
EQ : Equipment						
Inspector Comment						
Instruct landowner to remove farm equipment from landside shoulder.

Looking north at farm equipment on landward shoulder.

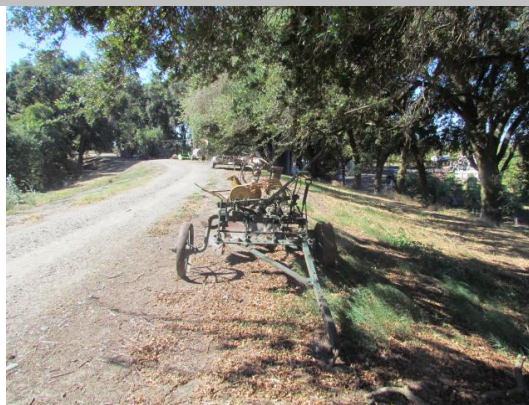
Photo 3 of 3 : SP\_2019\_RD0999\_236\_156\_20190307\_00068.jpg

Looking south at farm equipment on landward shoulder.

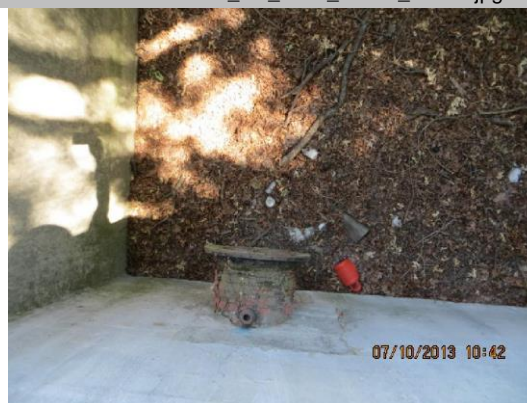
Photo 3 of 3 : UCIP\_SP\_2019\_53373\_25936.jpg

Comment Code						
Inspector Comment						
FS_ID:53373 DS_ID:22863 EP_NO: N/A Repair Type: Urgent Crossing Status: Found UCIP Comments: 07/26/2018 Same as last inspection; appears abandoned. Could not find outlet on LS. Erosion around WS concrete box base so crossing remains Urgent (D. Sanoski - DWR UCIP).07/07/2016 - Pipe abandoned and appears to be open inside the concrete box on the WS shoulder. No appurtenances visible from the LS. (T. Hatch/UCIP)07/10/2013 - Pipe abandoned and open on both ends. Concrete pump pit foundation undermined at WS toe. Pipe should be abandoned properly (W. Wylie/UCIP) FIELD_STRUCT_DESC: *ABANDONED* 14-inch (measured) steel irrigation pipe through the levee, 4.8 feet below the crown. 9-foot by 14-foot concrete pump pit on the waterside (WS) slope. Pipe open on the WS inlet to pump pit. [Additional Reference(s): DWR Levee Log, 1992, 16-inch pipe listed. USACE Sacramento O&M Manual 113 (Revised), October 1966, (HLM 7.60), abandoned 16-inch pipe listed]. FS Date: 7/26/2018 1:10:00 PM

Pipe open at pump pit on WS toe.

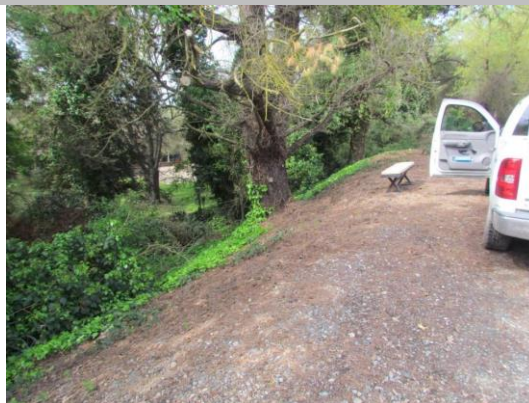
Photo 1 of 2 : SP\_2019\_RD0999\_236\_66\_20190307\_00026.jpg

LM Start	<b>7.54</b>	Rating **	U	Issue No.	<b>66 (cont)</b>
LM End	<b>7.58</b>	Issue Type +	En	Location *	LS

Looking east at landscaping at bottom half of levee. (Spring 2017)

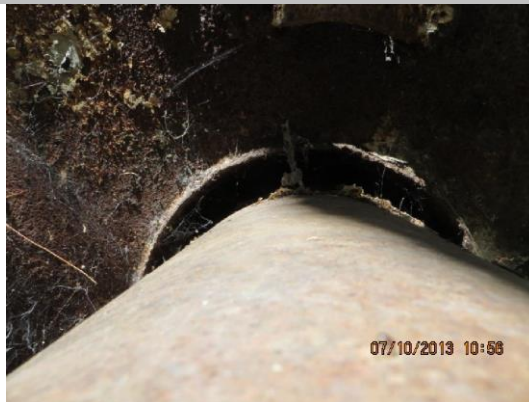
Photo 2 of 3 : UCIP\_SP\_2019\_15624\_25968.jpg

Notice: No grout between sleeved pipes.

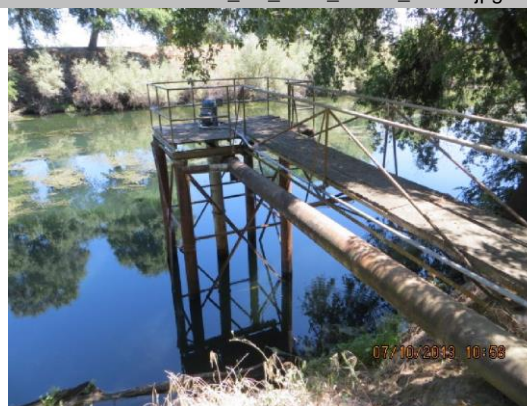
Photo 3 of 3 : UCIP\_SP\_2019\_15624\_25967.jpg

LM Start	7.57	Rating **	M	Issue No.	247 (cont)	
LM End	7.57	Issue Type +	En	Location *		
Category	Supplemental			GPS Latitude/Longitude		
				Start		End
Item	DWR UCIP Field Study			38.403993 °		38.403993 °
				-121.541626 °		-121.541626 °
DWR ID	22864					
Comment Code						
Inspector Comment						
FS_ID:15624 DS_ID:22864 EP_NO: N/A Repair Type: Non-Urgent Crossing Status: Found UCIP Comments: Annular space needs to be grouted between the 12 and 14-inch pipes. FIELD_STRUCT_DESC: 12-inch steel irrigation pipe sleeved through the 14-inch pipe through the levee, 7 feet below the crown. Annular space not grouted. 36-inch concrete standpipe on the landside (LS) toe. [Additional Reference(s): DWR Levee Log, 1992. USACE Sacramento O&M Manual 113 (Revised), October 1966, (HLM 7.65), 12-inch pipe listed]. FS Date: 7/10/2013

Pump on metal pier with walkway at WS toe

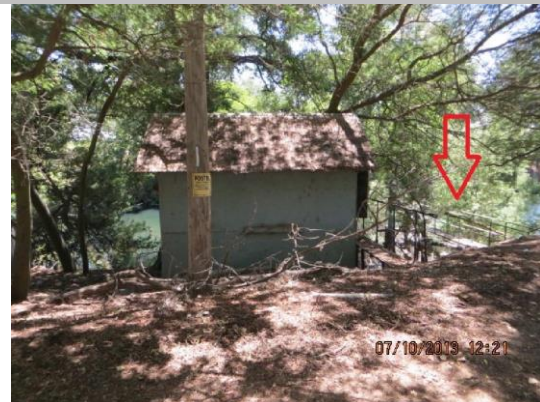
Photo 1 of 3 : UCIP\_SP\_2019\_15683\_26102.jpg

Comment Code					
Inspector Comment					
FS_ID:15683 DS_ID:22881 EP_NO: 13463 Repair Type: Non-Urgent Crossing Status: Found UCIP Comments: Pipe exposed in excavation on LS shoulder at what may be a leak. FIELD_STRUCT_DESC: 12-inch steel irrigation pipe through the levee, 2.5 feet below the crown. Pump on pile structure with walkway on the waterside (WS) toe. 12-inch polyvinyl chloride (PVC) standpipe on the landside (LS) toe next to filter plant and shed. 1.5-inch polyvinyl chloride (PVC) electrical conduit at the same location. (12-inch pipe authorized under Permit No. 13463, 1982 - John Plyman, existing 8-inch pipe was grouted in-place). FS Date: 7/10/2013

Pump on metal pier with walkway on WS slope.

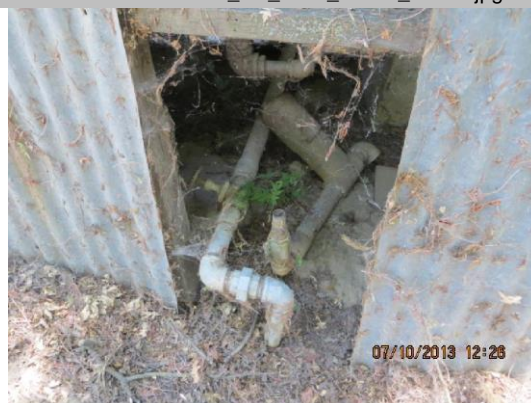
Photo 2 of 2 : UCIP\_SP\_2019\_15664\_26083.jpg

LM Start	8.05	Rating **	M	Issue No.	252 (cont)	
LM End	8.05	Issue Type +	En	Location *		
Category	Supplemental			GPS Latitude/Longitude		
				Start		End
Item	DWR UCIP Field Study			38.409488 °		38.409488 °
				-121.540833 °		-121.540833 °
DWR ID	22870					
Comment Code						
Inspector Comment						
FS_ID:15664 DS_ID:22870 EP_NO: N/A Repair Type: Non-Urgent Crossing Status: Found UCIP Comments: Pipe appears abandoned and should be done so properly. FIELD_STRUCT_DESC: 2-inch galvanized iron domestic water line through the levee, 12.5 feet below the crown. Gate valve and domestic pressure system in pump house on the waterside (WS) slope. [Additional Reference(s): DWR Levee Log, 1992. USACE Sacramento O&M Manual 113 (Revised), October 1966, (HLM 8.14)]. FS Date: 7/10/2013

Pipe visible inside pumphouse on WS slope.

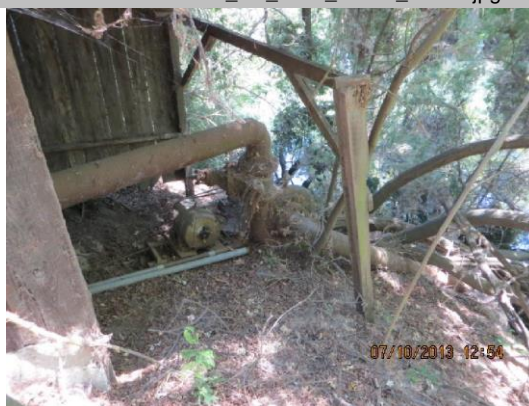
Photo 3 of 3 : UCIP\_SP\_2019\_15685\_26104.jpg

Comment Code						
Inspector Comment						
FS_ID:15685 DS_ID:22871 EP_NO: 4851 Repair Type: Non-Urgent Crossing Status: Found UCIP Comments: Pipe appears to be abandoned and should be done so properly. FIELD_STRUCT_DESC: 8-inch steel irrigation pipe through the levee, 6.2 feet below the crown. Gate valve in pump house on the waterside (WS) slope. Service poles on both slopes. (no permit found for the install of original 8-inch pipe; 20-foot section of existing 8-inch pipe was replaced with new 8-inch pipe work authorized under Permit No. 4851, 1965 - J. Plyman). [Additional Reference(s): DWR Levee Log, 1992. USACE Sacramento O&M Manual 113 (Revised), October 1966, (HLM 8.23)]. FS Date: 7/10/2013

Pump and gate valve in pump house on WS toe.

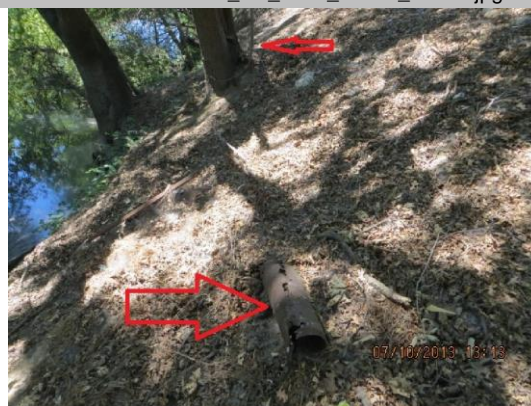
Photo 1 of 3 : UCIP\_SP\_2019\_15686\_26109.jpg

LM Start	8.29	Rating **	M	Issue No.	254
LM End	8.29	Issue Type +	En	Location *	
Category	Supplemental			GPS Latitude/Longitude	
				Start	End
Item	DWR UCIP Field Study			38.409264 °	38.409264 °
				-121.536659 °	-121.536659 °
DWR ID	22872				
Comment Code					
Inspector Comment					
FS_ID:15686 DS_ID:22872 EP_NO: N/A Repair Type: Non-Urgent Crossing Status: Indicator Found UCIP Comments: Type of pipe abandonment needs to be verified. FIELD_STRUCT_DESC: *ABANDONED* 8-inch steel irrigation pipe through the levee, 11.7 feet below the crown. No control valves. 1.5-inch galvanized iron electrical conduit found on the waterside (WS) slope at oak tree. 8-inch pipe debris visible on the WS slope. [Additional Reference(s): DWR Levee Log, 1992. USACE Sacramento O&M Manual 113 (Revised), October 1966, (HLM 8.43)]. FS Date: 7/10/2013

8-inch pipe debris with 1.5-inch electrical conduit visible in background on WS slope.

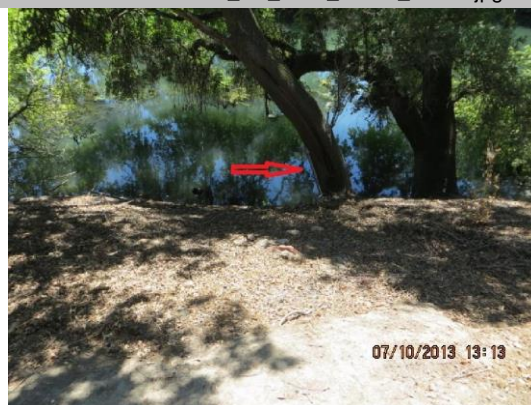
Photo 2 of 3 : UCIP\_SP\_2019\_15686\_26108.jpg

1.5-inch electrical conduit visible on WS slope next to oak.

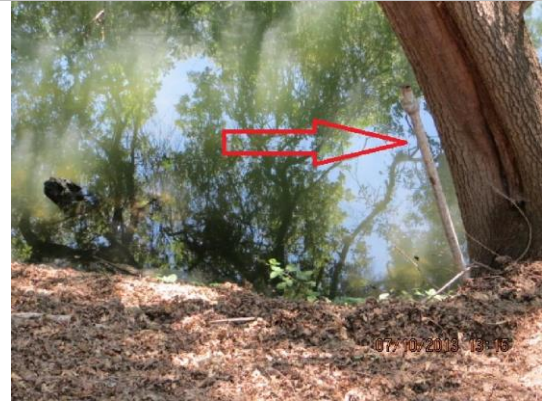
Photo 3 of 3 : UCIP\_SP\_2019\_15686\_26107.jpg

LM Start	8.29	Rating **	M	Issue No.	254 (cont)	
LM End	8.29	Issue Type +	En	Location *		
Category	Supplemental			GPS Latitude/Longitude		
				Start	End	
Item	DWR UCIP Field Study			38.409264 °	38.409264 °	
				-121.536659 °	-121.536659 °	
DWR ID	22872					
Comment Code						
Inspector Comment						
FS_ID:15686 DS_ID:22872 EP_NO: N/A Repair Type: Non-Urgent Crossing Status: Indicator Found UCIP Comments: Type of pipe abandonment needs to be verified. FIELD_STRUCT_DESC: *ABANDONED* 8-inch steel irrigation pipe through the levee, 11.7 feet below the crown. No control valves. 1.5-inch galvanized iron electrical conduit found on the waterside (WS) slope at oak tree. 8-inch pipe debris visible on the WS slope. [Additional Reference(s): DWR Levee Log, 1992. USACE Sacramento O&M Manual 113 (Revised), October 1966, (HLM 8.43)]. FS Date: 7/10/2013

1.5-inch electrical conduit visible on WS slope next to oak.

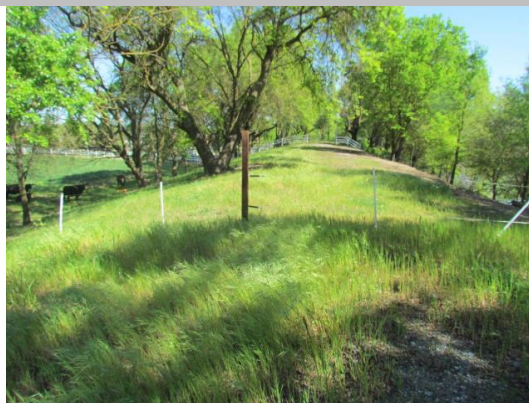
Photo 1 of 1 : SP\_2019\_RD0999\_236\_187\_20190307\_00087.jpg

LM Start	8.50	Rating **	M	Issue No.	187
LM End	8.50	Issue Type +	En	Location *	CR
Category	Earthen Levee			GPS Latitude/Longitude	
				Start	End
Item	Encroachments			38.409395 °	38.409395 °
				-121.533593 °	-121.533593 °
DWR ID	DWR_RD0999_05_s_2015_187				
Comment Code					
FE : Fence					
Inspector Comment					
Landowner installed an electrical fence across levee crown without a permit.

Looking east at new electrical fence across levee crown and landward slope. (Spring 2015)

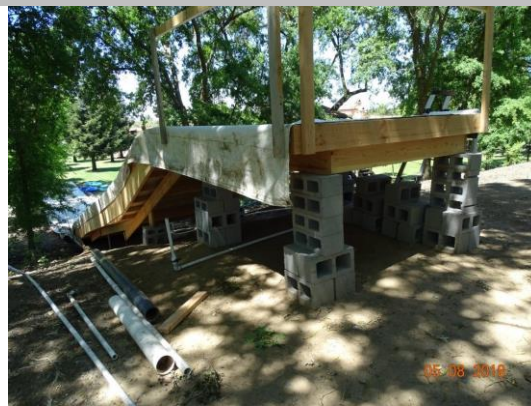
Photo 1 of 3 : SP\_2019\_RD0999\_236\_222\_20190307\_00098.jpg

Encroachment waterslide landside looking north.

LM Start	8.54	Rating **	U	Issue No.	222
LM End	8.54	Issue Type +	En	Location *	LS
Category	Earthen Levee			GPS Latitude/Longitude	
				Start	End
Item	Encroachments			38.409931 °	38.409931 °
				-121.533033 °	-121.533033 °
DWR ID	DWR_RD0999_05_f_2016_222				
Comment Code					
PL : Pool					
Inspector Comment					
Instruct landowner to remove slip and slide and pvc pipes on landside slope.

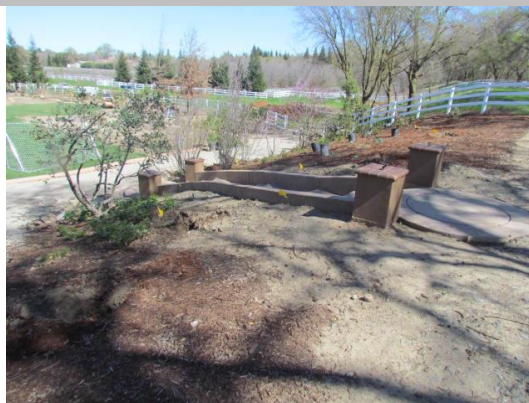
Photo 1 of 2 : SP\_2019\_RD0999\_236\_196\_20190307\_00090.jpg

LM Start	8.58	Rating **	M	Issue No.	196
LM End	8.58	Issue Type +	En	Location *	LS
Category	Earthen Levee			GPS Latitude/Longitude	
				Start	End
Item	Encroachments			38.410279 °	38.410279 °
				-121.532414 °	-121.532414 °
DWR ID	DWR_RD0999_05_s_2014_196				
Comment Code					
ST : Stairway					
Inspector Comment					
Landowner installed concrete stairs, sprinkler, and plantings on landside slope without CVFPB permit.

Looking east at concrete stairs, sprinklers, and plantings on landward slope.

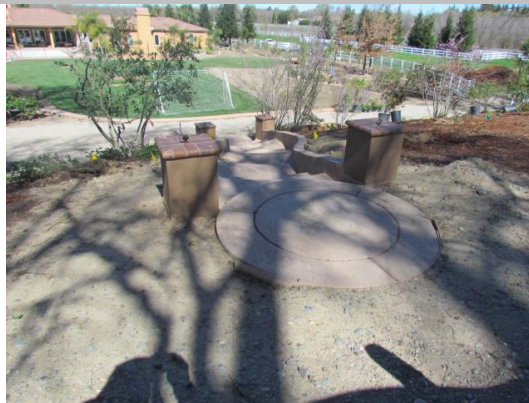
Photo 2 of 2 : SP\_2019\_RD0999\_236\_196\_20190307\_00091.jpg

Looking north at concrete stairs on landward slope.

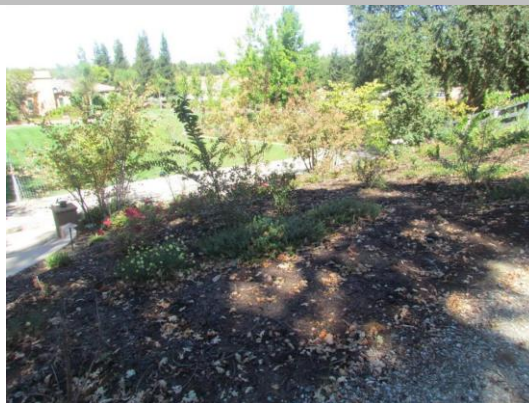
Photo 1 of 1 : SP\_2019\_RD0999\_236\_126\_20190307\_00051.jpg

LM Start	8.59	Rating **	M	Issue No.	126
LM End	8.59	Issue Type +	En	Location *	LS
Category	Earthen Levee			GPS Latitude/Longitude	
				Start	End
Item	Vegetation			38.410283 °	38.410283 °
				-121.532353 °	-121.532353 °
DWR ID	DWR_RD0999_05_s_2012_126				
Comment Code					
V6 : Landscaping					
Inspector Comment

Looking northeast at landscaping on landward slope.

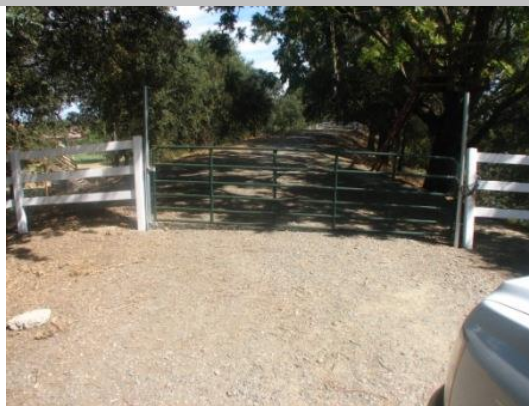
Photo 1 of 2 : SP\_2019\_RD0999\_236\_103\_20190307\_00048.jpg

View of fence &amp; gate across levee crown, landside &amp; waterside slope.

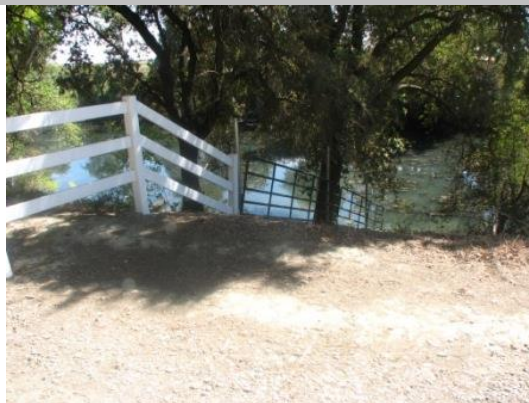
Photo 2 of 2 : SP\_2019\_RD0999\_236\_103\_20190307\_00049.jpg

Unauthorized fence that extends from landside toe to waterside toe.

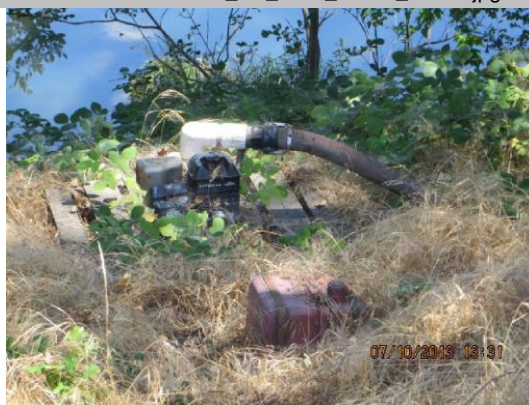
Photo 1 of 2 : UCIP\_SP\_2019\_16345\_27558.jpg

LM Start	8.62	Rating **	M	Issue No.	255
LM End	8.62	Issue Type +	En	Location *	
Category	Supplemental			GPS Latitude/Longitude	
				Start	End
Item	DWR UCIP Field Study			38.410531 °	38.410531 °
				-121.531785 °	-121.531785 °
DWR ID	23990				
Comment Code					
Inspector Comment					
FS_ID:16345 DS_ID:23990 EP_NO: N/A Repair Type: Non-Urgent Crossing Status: Found UCIP Comments: Need to determine permit No for crossing or remove it. FIELD_STRUCT_DESC: 3-inch plastic irrigation hose over the top of the levee. Small portable pump on the waterside (WS) toe. FS Date: 7/10/2013

Portable pump on WS toe.

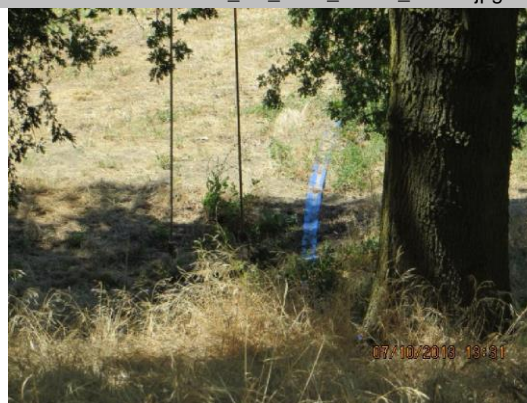
Photo 2 of 2 : UCIP\_SP\_2019\_16345\_27557.jpg

Plastic hose visible on LS toe.

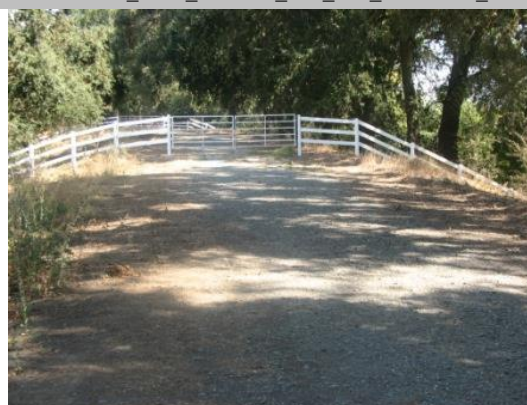
Photo 1 of 1 : SP\_2019\_RD0999\_236\_104\_20190307\_00050.jpg

LM Start	8.63	Rating **	M	Issue No.	104
LM End	8.63	Issue Type +	En	Location *	CR
Category	Earthen Levee			GPS Latitude/Longitude	
				Start	End
Item	Encroachments			38.410617 °	38.410617 °
				-121.531694 °	-121.531694 °
DWR ID	DWR_RD0999_05_s_2019_104				
Comment Code					
FE : Fence					
Inspector Comment					
There is an unauthorized fence and gate that extends from landside toe across levee crown to waterside toe.

View of unauthorized fence and gate that extends from landside toe across levee crown to waterside toe.

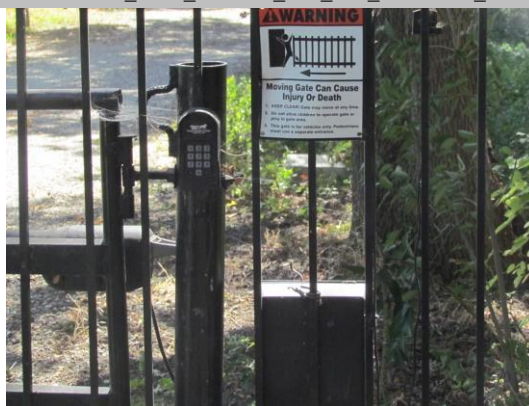
Photo 1 of 2 : SP\_2019\_RD0999\_236\_224\_20190307\_00101.jpg

LM Start	8.82	Rating **	M	Issue No.	224
LM End	8.82	Issue Type +	En	Location *	CR
Category	Earthen Levee			GPS Latitude/Longitude	
				Start	End
Item	Encroachments			38.412718 °	38.412718 °
				-121.529724 °	-121.529724 °
DWR ID	DWR_RD0999_05_f_2016_224				
Comment Code					
FE : Fence					
Inspector Comment					
Landowner installed gate across levee crown without a permit.

Looking at code pad on right side of gate.

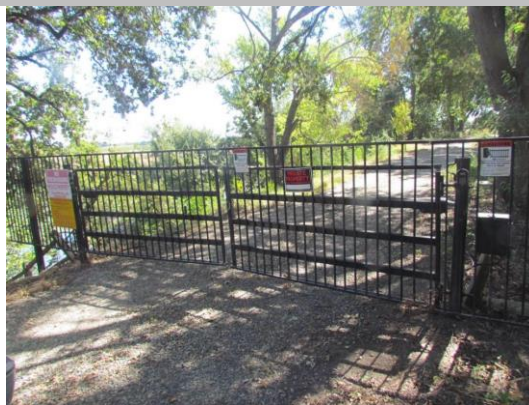
Photo 2 of 2 : SP\_2019\_RD0999\_236\_224\_20190307\_00102.jpg

LM Start	<b>8.82</b>	Rating **	M	Issue No.	<b>224 (cont)</b>
LM End	<b>8.82</b>	Issue Type +	En	Location *	CR

Looking west at code pad on right side of gate.

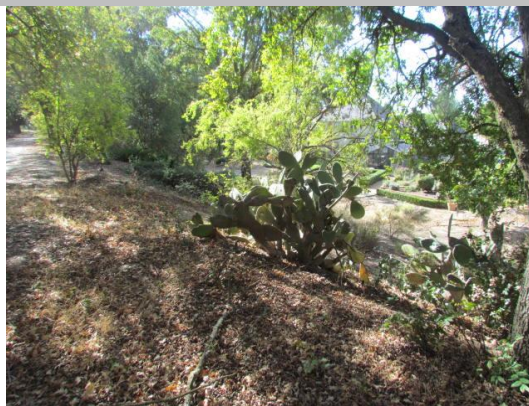
Photo 1 of 1 : SP\_2019\_RD0999\_236\_127\_20190307\_00052.jpg

LM Start	8.90	Rating **	M	Issue No.	127
LM End	8.92	Issue Type +	En	Location *	LS
Category	Earthen Levee			GPS Latitude/Longitude	
				Start	End
Item	Vegetation			38.413780 °	38.414138 °
				-121.529727 °	-121.529772 °
DWR ID	DWR_RD0999_05_s_2012_127				
Comment Code					
V6 : Landscaping					
Inspector Comment					
Instruct landowner to remove cactus and other plants from landside slope. Pomegranate trees on shoulder are not permitted on levee section. Sprinklers need a permit.

Looking west at cactus and other vegetation on landward slope.

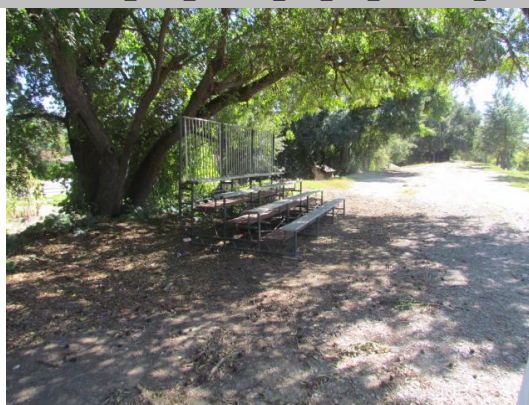
Photo 1 of 1 : SP\_2019\_RD0999\_236\_158\_20190307\_00069.jpg

LM Start	9.15	Rating **	M	Issue No.	158
LM End	9.15	Issue Type +	En	Location *	LS
Category	Earthen Levee			GPS Latitude/Longitude	
				Start	End
Item	Encroachments			38.415709 °	38.415709 °
				-121.527393 °	-121.527393 °
DWR ID	DWR_RD0999_05_f_2013_158				
Comment Code					
EQ : Equipment					
Inspector Comment					
Instruct landowner to remove bleachers from landside shoulder.

Looking northeast at bleachers stored on landward shoulder.

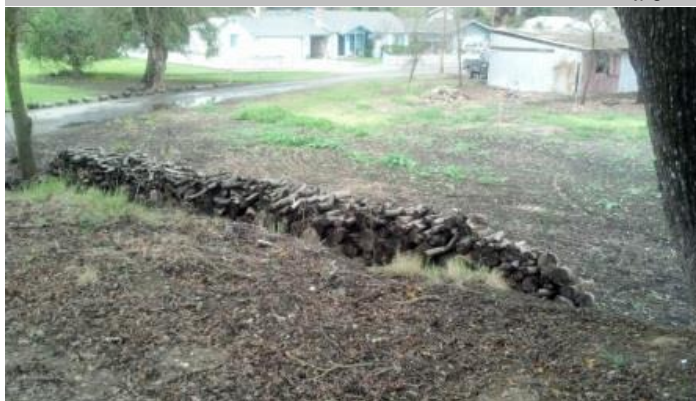
Photo 1 of 2 : SP\_2019\_RD0999\_236\_145\_20190307\_00058.jpg

LM Start	9.44	Rating **	M	Issue No.	145
LM End	9.44	Issue Type +	En	Location *	LS
Category	Earthen Levee			GPS Latitude/Longitude	
				Start	End
Item	Encroachments			38.413755 °	38.413755 °
				-121.523723 °	-121.523723 °
DWR ID	DWR_RD0999_05_s_2013_145				
Comment Code					
FW : Firewood					
Inspector Comment					
Instruct landowner to remove firewood stockpile from levee easement.

Looking north at firewood pile at landside toe.

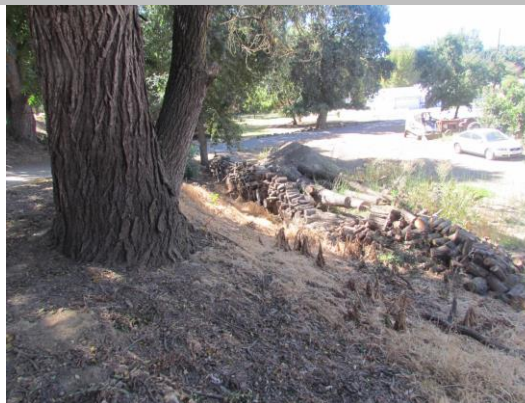
Photo 2 of 2 : SP\_2019\_RD0999\_236\_145\_20190307\_00059.jpg

LM Start	<b>9.44</b>	Rating **	M	Issue No.	<b>145 (cont)</b>
LM End	<b>9.44</b>	Issue Type +	En	Location *	LS

Looking northwest at firewood at landward toe.
